# A System Theoretic Analysis of the “7.23” Yong-Tai-Wen Railway Accident

Dajiang Suo

**Abstract:** This paper seeks to analyze the “7.23” Yongwen Railway accident in China from a system theoretic perspective. In particular, the STAMP safety control structure for this accident has been constructed and divided into two respective processes including system development and operation, which are then analyzed at each level. Furthermore, to understand why and how the system evolved over time, system dynamics models are constructed to describe the changes indirectly leading to the accident. As could be seen, this analysis raises some questions which are not included in the investigation report but critical to the comprehensive understanding of the accident. Based on the analysis results, recommendations are generated aiming at preventing the same kind of accidents in the future.

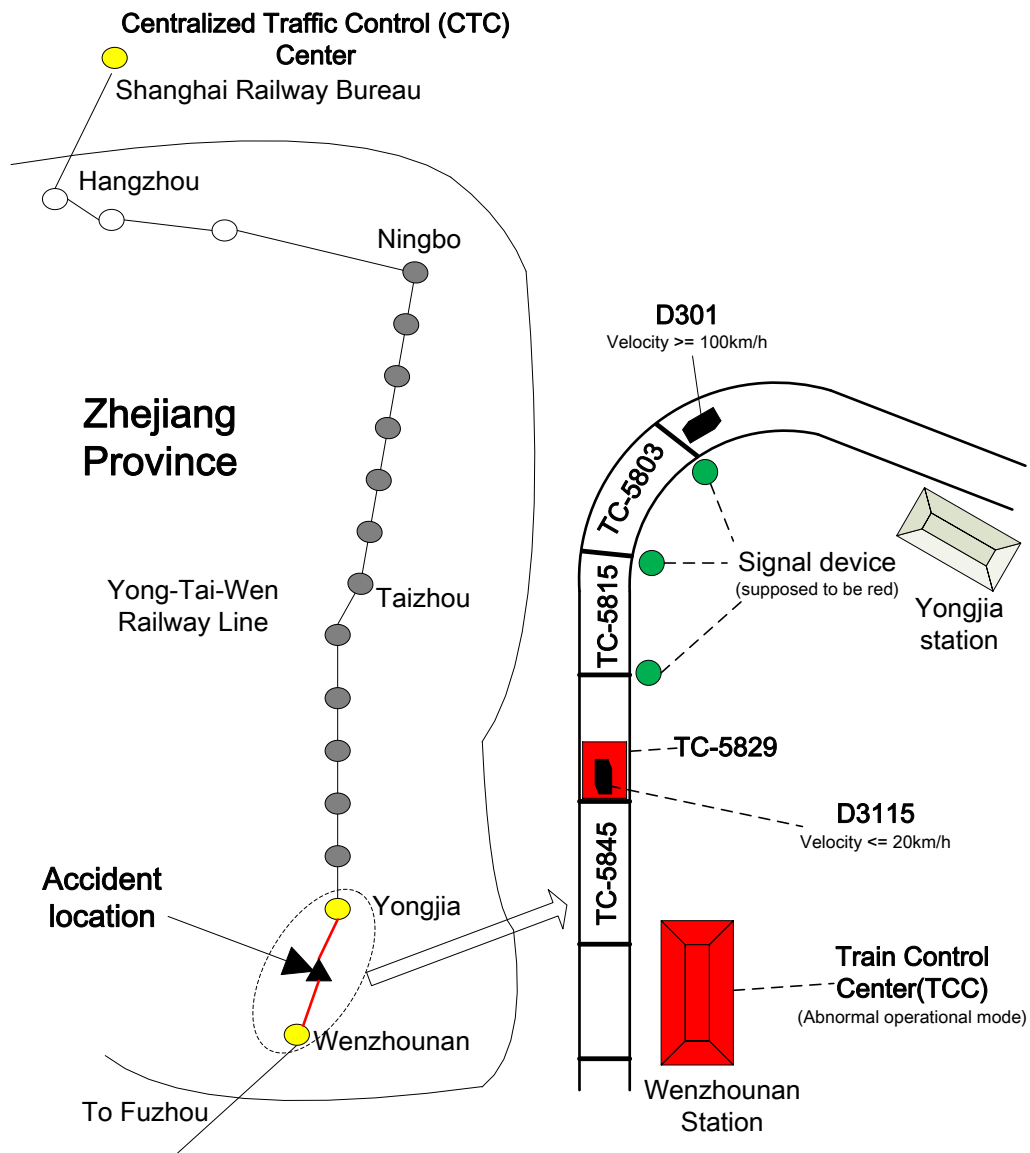
Figure 1. The location of the accident and its surrounding environment

Both D3115 and D301 were behind schedule and reached Yongjia railway station at 19:51 and 20:12, respectively. The Railway station changed its operational mode from automatic control to abnormal control (man-control) because of a failure in the track circuit. A “Red-Light strip”, which represents the occupancy of the railway section, appeared in the monitor of the CTC, but actually there was no train in that section. At 20:14, D3115 left Yongjia station and reached 5829AG at 20:21. Due to the failure of Track circuit, it stopped automatically for nearly eight minutes and failed to restart until 20:29. After that it kept running at the speed almost 20 kilometers per hour according to the railway regulation under abnormal conditions. At the same time, D301 also left from Yongjia station to Wenzhounan station at 20:24 and was supposed to decelerate when it received signals from the Track circuit or encountered the red light of the signal device. Unfortunately, failures in the TCC made erroneous signal sent to D301 and the signal light, indicating that there was no train in section 5829 and the signal lights in section 5815 and 5803 turned green. As a consequence, D301 did not stop or decelerate at Section 5815 and 5803 (As shown in Figure 1).

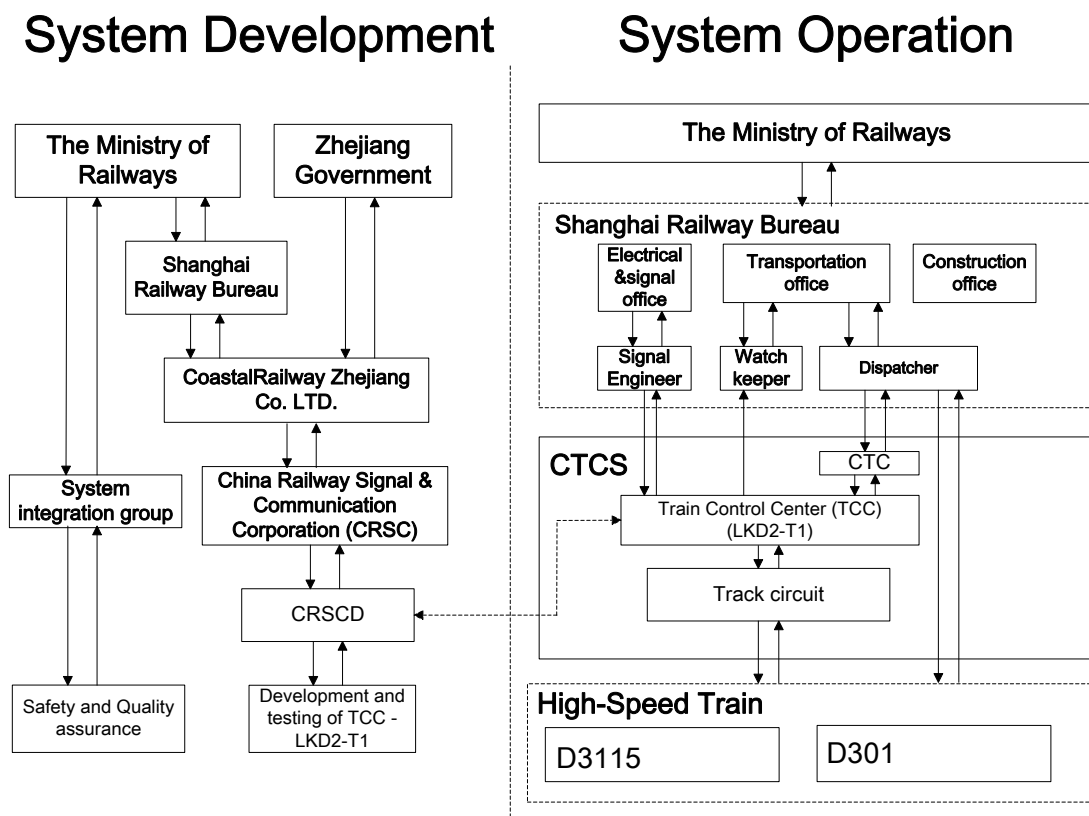
The safety control structure includes both the construction of the high-speed railway line within Zhejiang Province and the operation of the Yong-Tai-Wen railway line, which is shown in Figure 3. It includes the High-Speed Train (D301 and D3115), the whole CTCS2 system, the Shanghai Railway Bureau and the Ministry of Railways on the right. The development structure (on the left) only incorporates those involved in the development of the signal&communication system because failures of signal devices are believed to be one of the main reasons for the accident. As mentioned before, there are two operational modes in this system (DACM and USCM). In the former, the CTC issues scheduling commands which transmit through TCC and the LEU and finally reach the ATP, which monitor the status information from the Track Circuit. If there is a Red light strip, the TCC will transmit to the USCM in which the train will be controlled by the coordination between the driver and the watch keepers in the station.

On the left of Figure 3 is the safety control structure of system development. The Coastal (Yong-Tai-Wen) Railway is its subsidiary company of Zhejiang Railway which is a state-owned liabilities limited company. It cooperates with the Ministry of Railways on behalf of the government of Zhejiang Province to holds and runs related national assets of jointly built railways. To make the discussion simple and easy to understand, Zhejiang Railway and the Coastal (Yong-Tai-Wen) Railway are referred to as Coastal Railway as a whole. It is responsible for the contract of investment and construction of the Yong-Tai-Wen coastal railway line in Zhejiang Province. The China Railway Signal&Communication Corporation (CRSC) is the contractor of the signal and communication system of the Yong-Tai-Wen railway line and responsible for the system integration of signal device. It also provides Track circuit to the CTCS system. Beijing National Railway Research&Design Institute of Signal&Communication Co., Ltd. (CRSCD), a subordinate enterprise of CRSC, designed and developed the TCC system – LKD2-T1.

Figure 3. Safety control structure of the High-Speed train accident

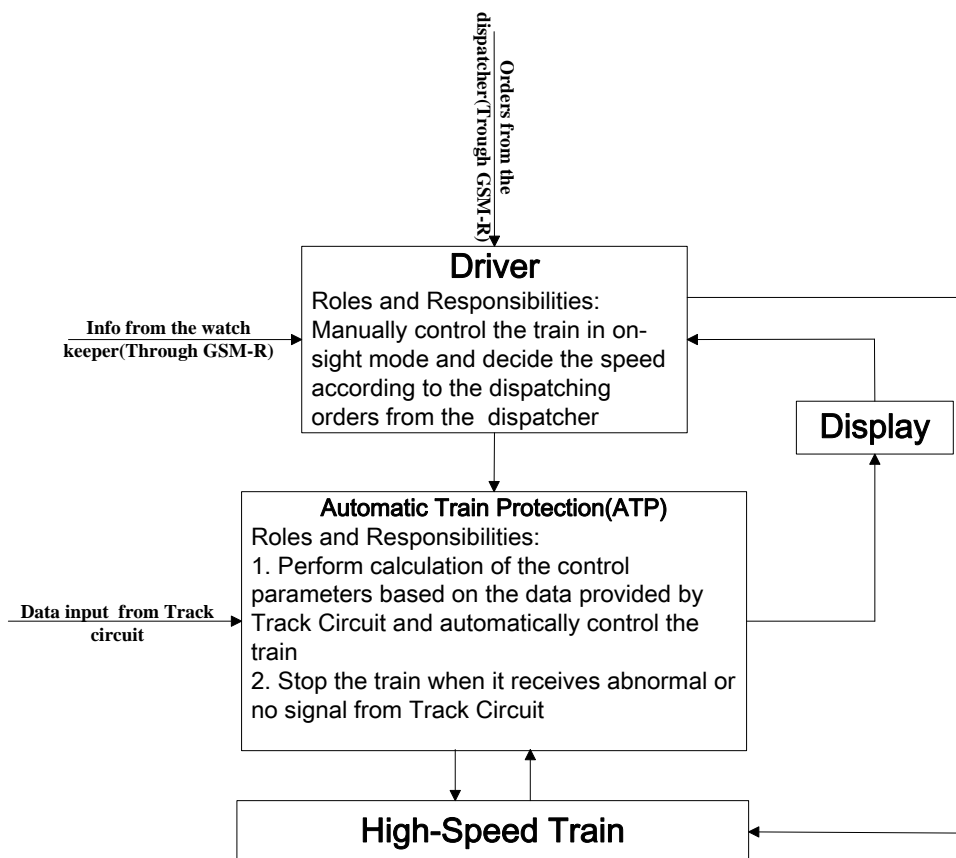
transmission of data to the ATP, it will stop the train immediately and transit to on-sight mode. In fact as shown in Figure 2, about 1 minute before the accident, the D3115 train was in on-sight mode running at a speed lower than 20 km/h and D301 was in monitoring mode with a high speed (99km/h). The ATP did not decelerate or stop D301 as designed when two trains were in the same section because the failed TCC transmit erroneous signal to it. To make things worse, the driver of the D301 did not realize that D3115 was in front not far away until it was too late. In the end, the D301 crashed into D3115 with a speed more than 90 kilometers per hour although the driver of the D301 performed the emergency brake. Obviously, 1 kilometer is not enough for the driver of D301 to stop the train safely.

Figure 4. On-Train control system

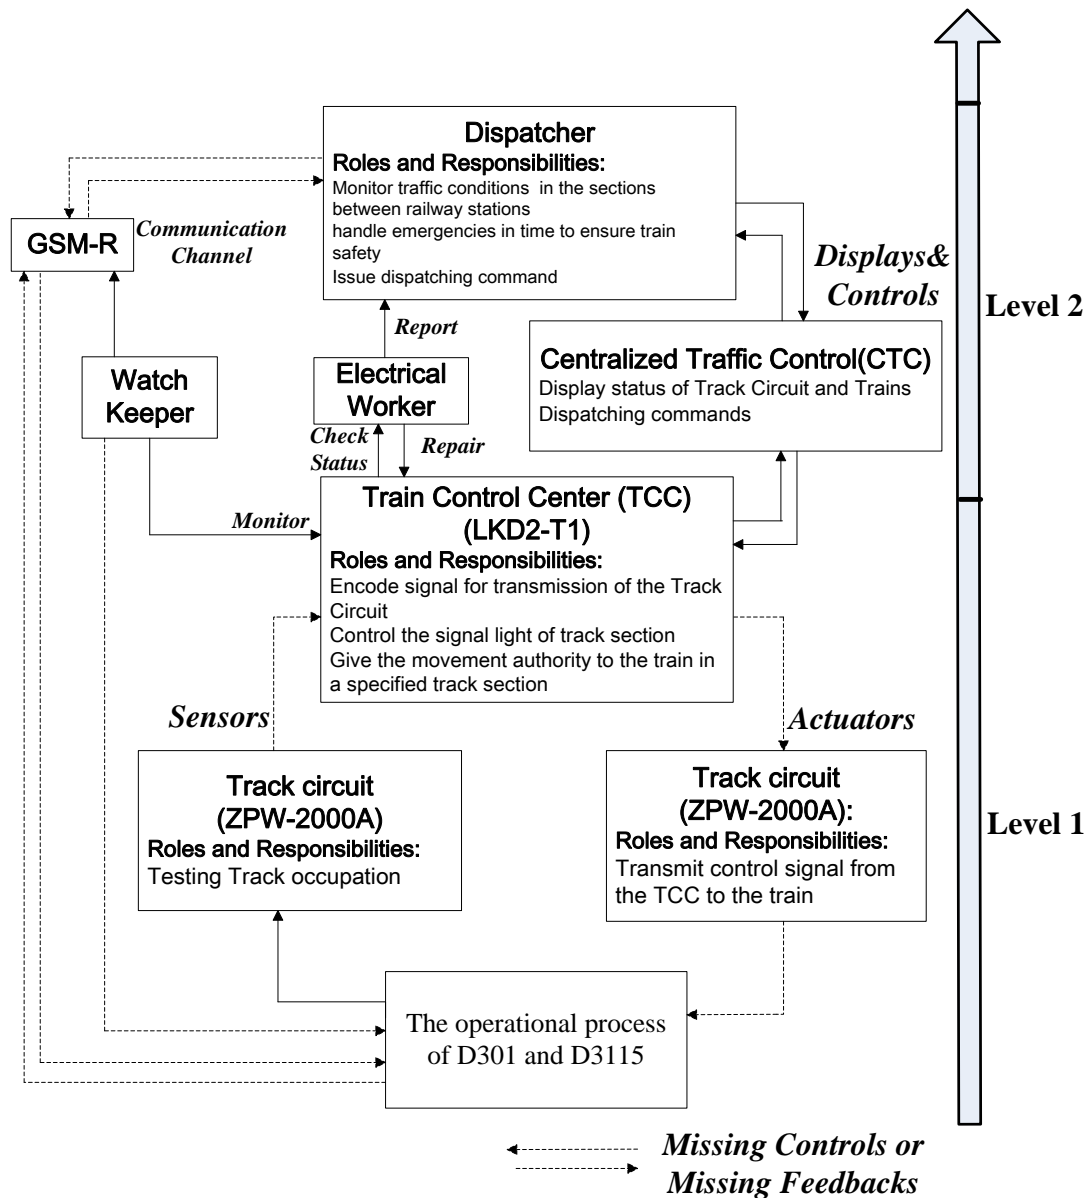
The whole ground Train control system is shown in Figure 5, which includes the physical controller – TCC located in Wenzhou station and the human controllers involved. As regulated in [10], the watch keeper should have asked the driver of D301 to stop the train as soon as hazards were found in the railway line. This mechanism, called “junction control for operation and maintenance of rolling stocks and locomotives” [10], is designed to notify the driver of the potential risks and ensure the safety of the train. In addition, it is the dispatch that has the responsibility to monitor the speed and position of the train. Therefore, questions like “Did the watch keeper or the dispatcher know the exact position of the D3115?” or “Did the errors in the signal lights are realized by any of the staff members?” should be addressed in order to understand their behaviors during the emergency. Unfortunately, this information is not included in the investigation report. Although the failures in the Train control system might lead to the erroneous signal being given to them, the related hazards could be identified by communications between them through the GSM-R (Communication system used in the railway system).

Figure 5. Train control system on the ground

As could be seen in Figure 5, there are three controllers involved in this accident (one automatic controller – TCC, and two human controllers – dispatcher and the watch keeper). From a control perspective, hazard appearing in Track circuit 5829 could be attributed to the conditions that the human controller failed to provide control commands to slow down or stop the train D301 while the automatic controller had abnormally issued command to stop the train D3115 in Track circuit 5829AG because of hardware failures. In other words, if the automatic controller had provided no commands to stop the train D3115 in 5829AG or the watch keeper and dispatcher had predicted the existence of hazards in this situation and took actions to stop the train D301, the accident could be prevented.

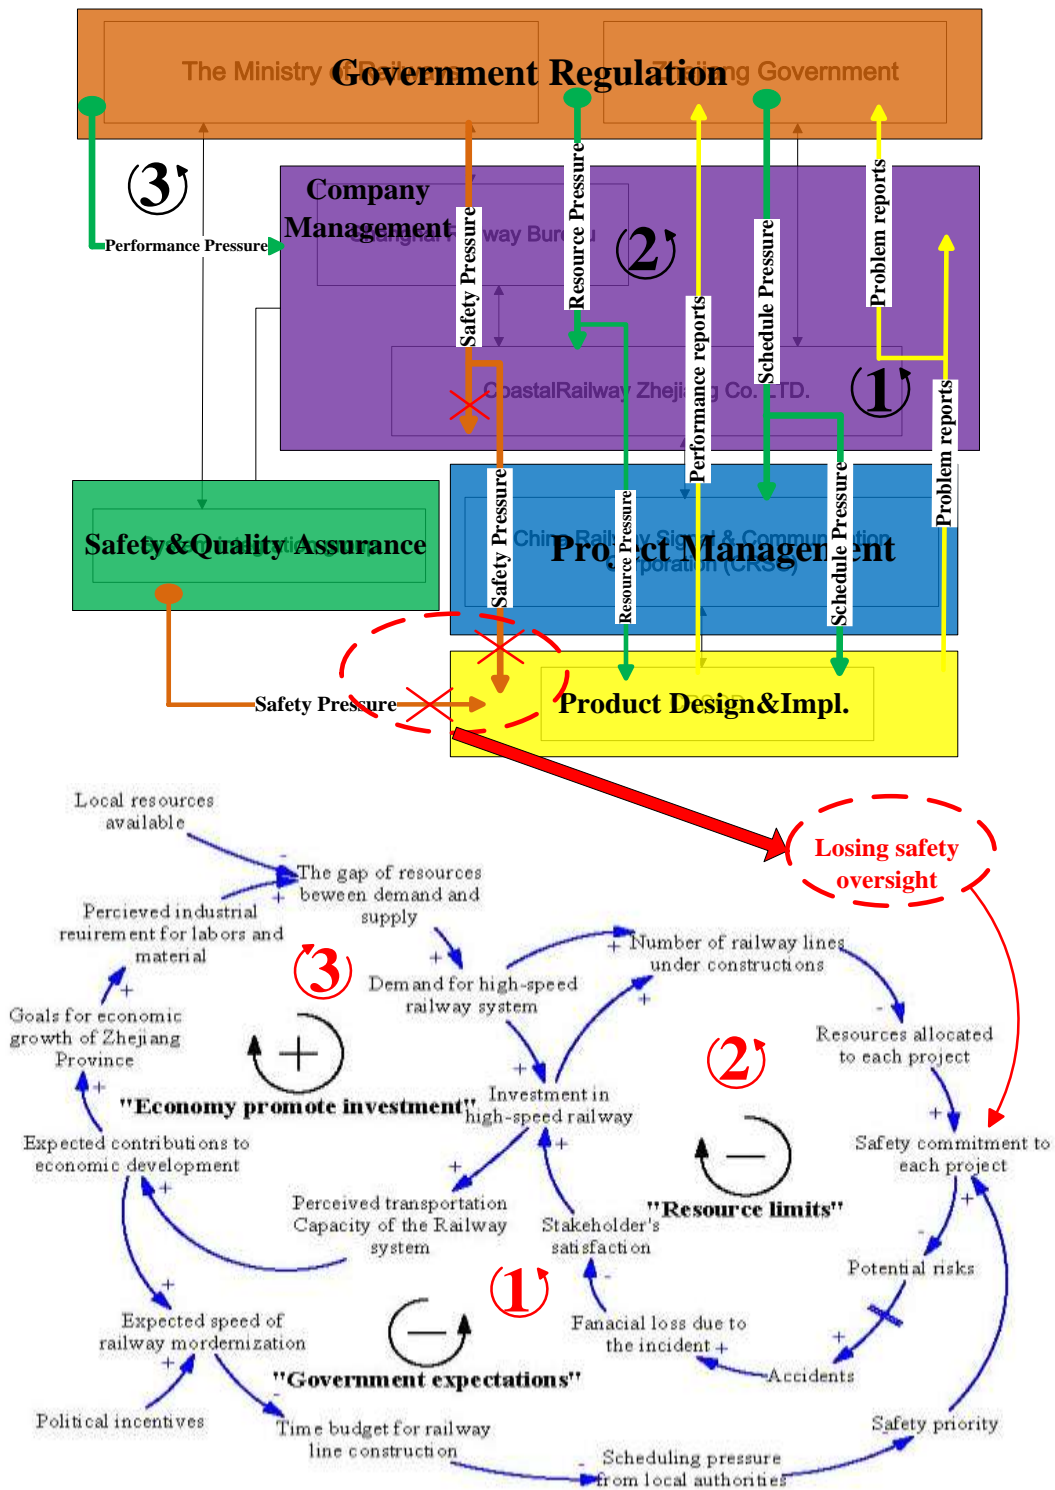
Figure 7. System dynamics of Zhejiang high-speed railway development

high-speed railway projects were cut by the minister of Railways and all the projects were stop temporarily for a complete safety inspection and this situation was reflected in the balancing loop “government expectations” ( bottom of Figure 7).

The other two causal loops (no. 2 and no. 3) in Figure.7, including one reinforcing loop which promote investment to the railway in Zhejiang Province and one balancing loop which would change resource allocation on each project due to decrease in stakeholders’ satisfaction with the project, could also be build as no.1 causal loop. As noted above, we do not distinguish different generic dynamic components but only consider the influence of these channels in STAMP on system safety and have it reflected in the dynamic risk management model. One thing should be addressed is that the project as a whole tend to decrease safety priority and commitment to safety due to other pressures. To make things worse, the channels for reinforcing safety oversight and transmitting safety pressures are missing for lack of safety resources and complacencies (red ellipse in Figure 7). It is pointed out in the investigation report that leaders in the CRSC believed that there are no problems with the signal&communication products because of the oral reports they received from the sub-organization. Consequently, they design flaw in the TCC was not discovered during the testing process. If safety oversight had been reinforced externally, or the project contractor, in this case the CRSC, had received more safety pressures from the management company, the safety commitment could have been maintained.

The second causal loop “resource limits” depicts total resources available to each projects and its impact on the safety situation of each project. Like the one described in [9], as the numbers of projects grew, the gap between the required capital resources and the funds provided by the stakeholders led to compromises in quality of design and the execution of safety regulations. The increasing potential of risks caused by Poor supervisions and coordination becomes inevitable. As a result, the rise in the accident rate made stakeholders unsatisfied with the project and the investment become less. In fact, the situation described above is the same with what happened after the 7.23 accident.

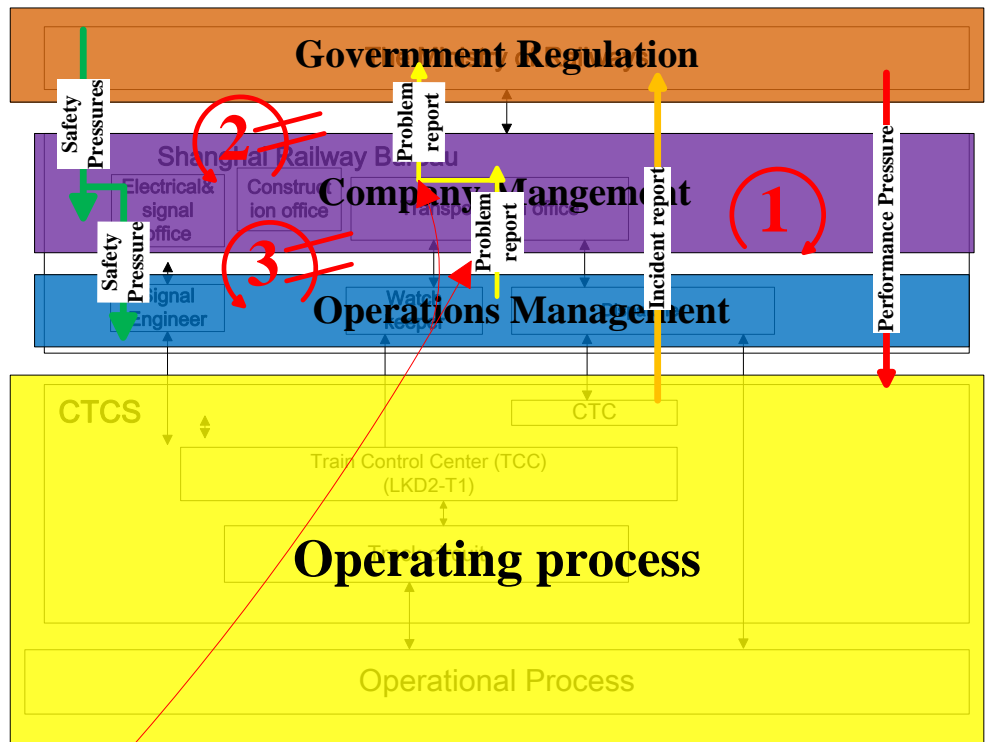
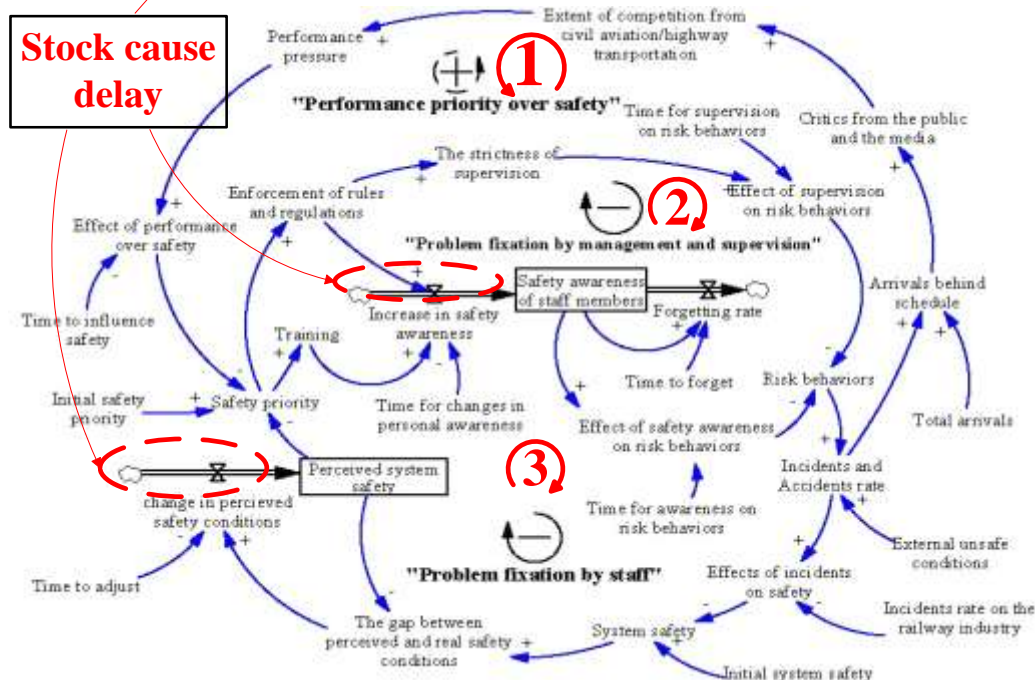
The method we used is the same as the one described above, except that the stock and flow structure have been introduced to model delays in the problem reporting channels (top of Figure.

8), which made the authority failed to realize the poor safety conditions and take actions accordingly until accidents happened. These effects are represented by “problem fixation” loops in Figure 8. Specifically, they are divided into two parts - management and supervision from the

Figure 8. System dynamics of Zhejiang high-speed railway operation

authority (no. 2 loop in Figure. 8) and efforts taken by the personnel (no. 3 loop in Figure. 8). Also, it takes some time to improve the safety awareness of them by training, which will decrease if the authority takes no actions to maintain its balanced level. Another factor should be mentioned is that the reduction in incidents would also generate complacency, which could lead to a lower
